**Flood Control Project Maintenance
Levee Inspections**

Fall 2018 Levee Maintenance Deficiency Summary Report

Reclamation District No. 0150 Merrit Island

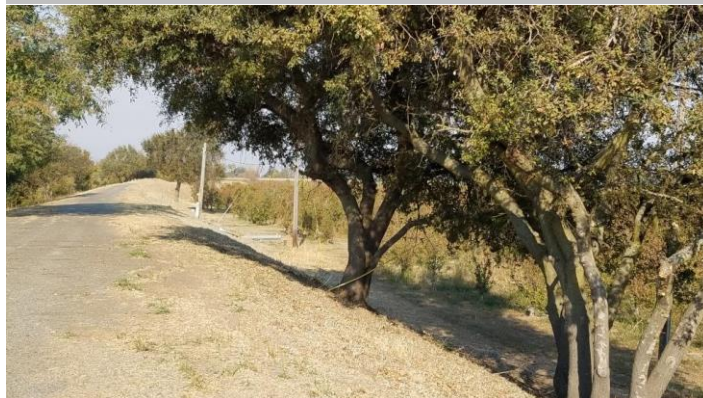
Photo 1 of 1 : FA_2018_RD0150_15_1_20181115_00002.jpg

LM Start	0.00	Rating **	A	Issue No.	1
LM End	0.48	Issue Type +	Ma	Location *	LS
Category	Earthen Levee			GPS Latitude/Longitude	
				Start	End
Item	Vegetation			38.332642 °	38.328362 °
				-121.583471 °	-121.576783 °
DWR ID	DWR_RD0150_01_f_2018_1				
Comment Code					
V1 : Control annual grass and weeds on the levee slopes and easements.					
Inspector Comment					
Annual vegetation is maintained.

View of landside vegetation. Fall 2018

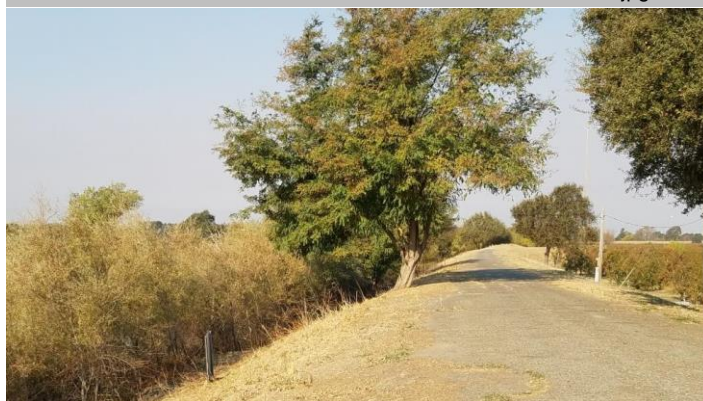
Photo 1 of 1 : FA_2018_RD0150_15_2_20181115_00001.jpg

LM Start	0.00	Rating **	A	Issue No.	2
LM End	0.48	Issue Type +	Ma	Location *	WS
Category	Earthen Levee			GPS Latitude/Longitude	
				Start	End
Item	Vegetation			38.332642 °	38.328362 °
				-121.583471 °	-121.576783 °
DWR ID	DWR_RD0150_01_f_2018_2				
Comment Code					
V1 : Control annual grass and weeds on the levee slopes and easements.					
Inspector Comment					
Annual vegetation is maintained.

View of waterside vegetation. Fall 2018

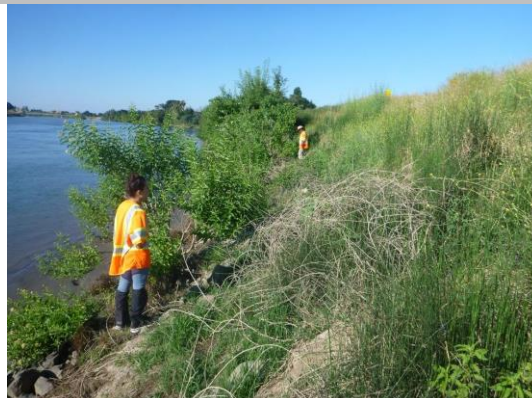
Description: The flood damage consists of a waterside erosion approximately 185 feet long on the west (right) bank of the Sacramento River. See attached pages for photos.

LM Start	0.11	Rating **	A/W	Issue No.	46 (cont)
LM End	0.14	Issue Type +	Ma	Location *	WS
Category	Supplemental			GPS Latitude/Longitude	
				Start	End
Item	2017 Storm Damage			38.329369 °	38.329767 °
				-121.574936 °	-121.574589 °
DWR ID	DWR_RD0150_02_f_2017_46				
Comment Code					
Inspector Comment					
Levee Evaluation Comments					
Description:The flood damage consists of a waterside erosion approximately 185 feet long on the west (right) bank of the Sacramento River. See attached pages for photos.					
Site ID No:286					
Site Designation:LMA-112					
Repair Type: Erosion					
Rating:Area of Concern					
Field Date:7/17/2017					
Notes: Crown is a paved road. Scarps upto 3 ft deep, not fully vertical though. Area of concern because erosion is not very deep into prism.

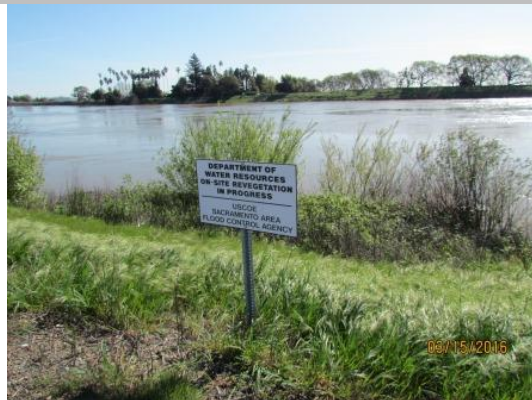
Photo 1 of 1 : FA_2018_RD0150_16_5_20180910_00002.jpg

LM Start	0.14	Rating **	A/W	Issue No.	5
LM End	4.77	Issue Type +	Ob	Location *	WS
Category	Earthen Levee			GPS Latitude/Longitude	
				Start	End
Item	Vegetation			38.329782 °	38.374641 °
				-121.574769 °	-121.524730 °
DWR ID	DWR_RD0150_02_s_2012_5				
Comment Code					
V8 : Environmental Requirements.					
Inspector Comment

View of the re-vegetation sign. Spring 2016

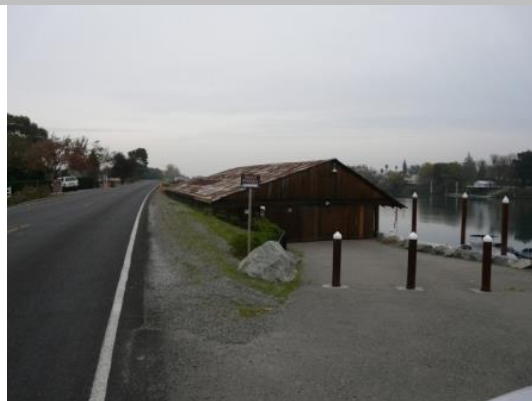
Photo 1 of 1 : FA_2018_RD0150_16_49_20180910_00027.jpg

LM Start	0.16	Rating **	U	Issue No.	49
LM End	0.16	Issue Type +	En	Location *	WS
Category	Earthen Levee			GPS Latitude/Longitude	
				Start	End
Item	Encroachments			38.330047 °	38.330047 °
				-121.574538 °	-121.574538 °
DWR ID	DWR_RD0150_02_s_2012_49				
Comment Code					
BU : Building					
Inspector Comment

Building located on waterside of levee.

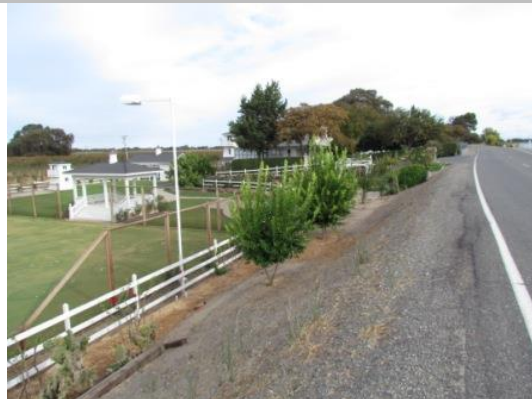
Photo 1 of 1 : FA_2018_RD0150_16_990_20180910_00072.jpg

LM Start	0.17	Rating **	M	Issue No.	990
LM End	0.21	Issue Type +	En	Location *	LS
Category	Earthen Levee			GPS Latitude/Longitude	
				Start	End
Item	Vegetation			38.330173 °	38.330576 °
				-121.574490 °	-121.574093 °
DWR ID	DWR_RD0150_02_s_2012_990				
Comment Code					
V6 : Landscaping					
Inspector Comment

Landscaping was found on the landside of the levee looking upstream.

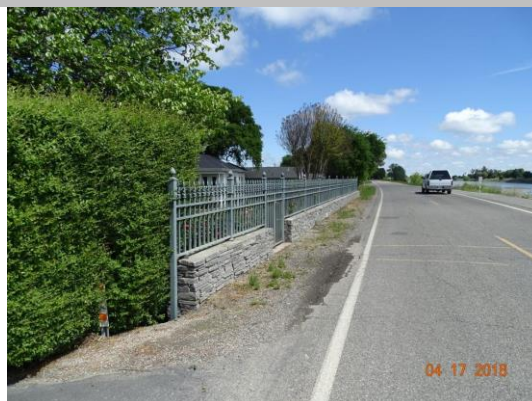
Photo 1 of 1 : FA_2018_RD0150_16_105_20180910_00061.jpg

LM Start	0.18	Rating **	U	Issue No.	105
LM End	0.20	Issue Type +	En	Location *	LS
Category	Earthen Levee			GPS Latitude/Longitude	
				Start	End
Item	Encroachments			38.330339 °	38.330500 °
				-121.574311 °	-121.574138 °
DWR ID	DWR_RD0150_02_s_2018_105				
Comment Code					
FE : Fence					
Inspector Comment					
Landowner has installed a fence blocking access to levee.

Iron fence was not included under Permit 17359-A; only retaining wall, terraced slope, and steps were approved on landside. Spring 2018

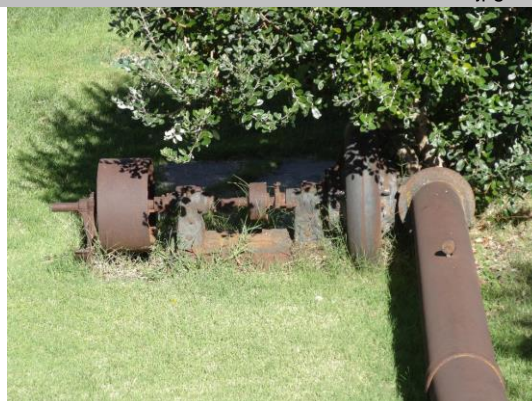
Photo 2 of 3 : UCIP_FA_2018_42700_34246.jpg

LS view: abandoned pipe and pump on landside toe.

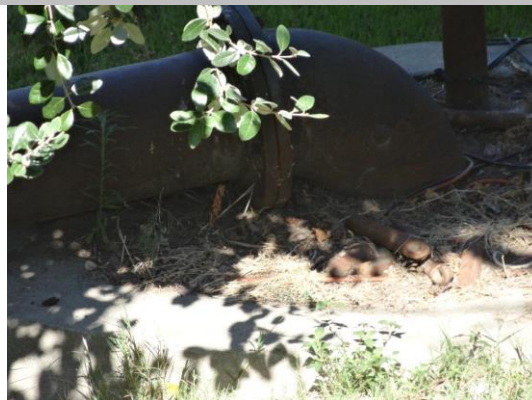
Photo 3 of 3 : UCIP_FA_2018_42700_34245.jpg

LS view: abandoned pipe and concrete box on landside toe.

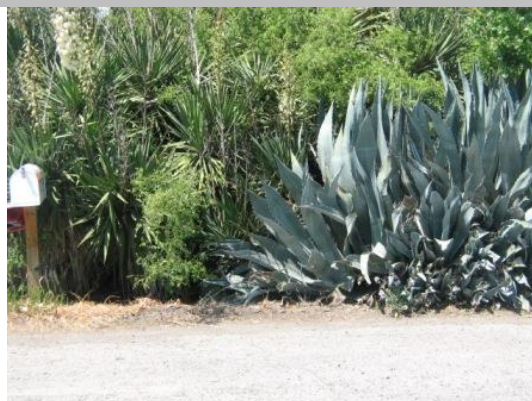
Photo 1 of 1 : FA_2018_RD0150_16_4_20180910_00001.jpg

Landscaping on landward slope of the levee.

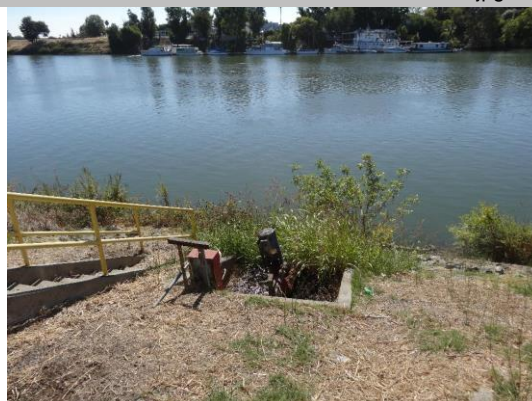
Photo 1 of 3 : UCIP_FA_2018_20268_34244.jpg

Comment Code						
Inspector Comment						
FS_ID:20268 DS_ID:22417 EP_NO: N/A Repair Type: Non-Urgent Crossing Status: Found UCIP Comments: - Water leaks from pressure breaker.- Distribution box at the landward toe not found/visible.- Service pole on LS toe. FIELD_STRUCT_DESC: 4-inch steel irrigation discharge pipe joined to a 6-inch steel irrigation discharge pipe which is in turn joined to a 10-inch steel irrigation discharge pipe through the levee, 5.8 feet below the crown. 1.5-inch electrical conduit through the levee, 3 feet below the crown. Pump and gate valve on the waterside (WS) slope. (Retention of an irrigation pumping plant, centrifugal pump, and gate valve on the WS levee slope with a 10-inch pipe through the levee authorized under Permit No. 9448, 1974 - William N. Runyon). [Additional Reference(s): DWR Levee Log, 2005]. FS Date: 8/27/2013

WS view: walkway/stairs, pump on levee slope.

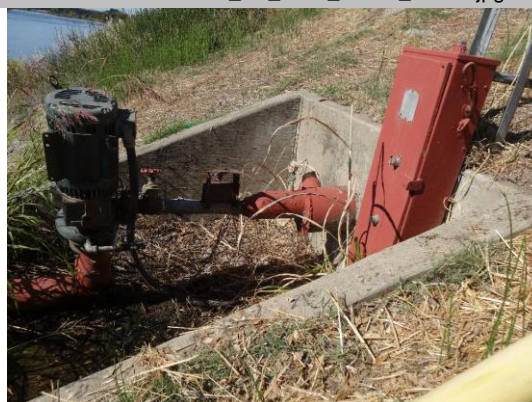
Photo 2 of 3 : UCIP_FA_2018_20268_34243.jpg

WS view: pump, electric control box, electric conduit on concrete pad.
Water leaks from pressure breaker.

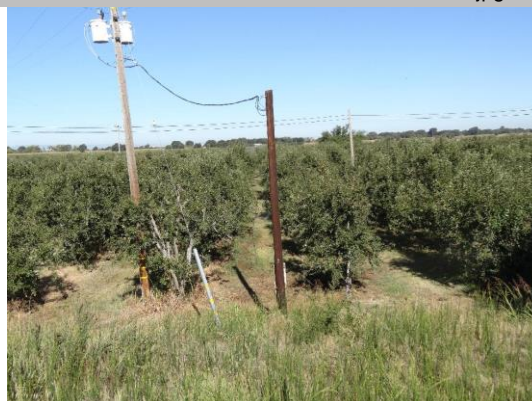
Photo 3 of 3 : UCIP_FA_2018_20268_34242.jpg

LS view: distribution box not found/visible on levee toe.

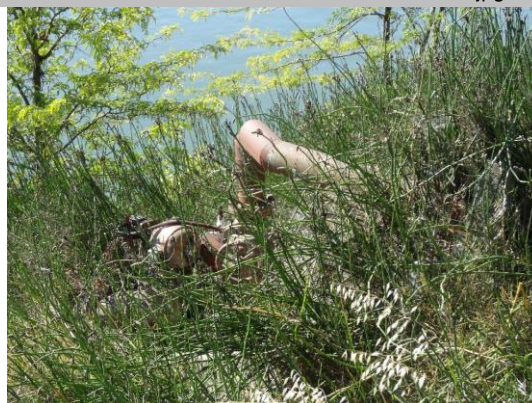
Photo 1 of 3 : UCIP_FA_2018_20267_34239.jpg

Comment Code						
Inspector Comment						
FS_ID:20267						
DS_ID:22418						
EP_NO: N/A						
Repair Type: Non-Urgent						
Crossing Status: Found						
UCIP Comments: - Abandoned pipe and pump.- Needs proper abandonment.						
FIELD_STRUCT_DESC: 6-inch steel irrigation discharge pipe and a 1-inch electrical conduit through the levee, invert elevation 3.5 feet below the crown. Pump and gate valve on the waterside (WS) slope. Electrical box on the WS slope. (Retention of an irrigation pumping plant, centrifugal pump, and gate valve on the WS with a 6-inch pipe through the levee authorized under Permit No. 9447, 1974 - Reuben A. Gentner). [Additional Reference(s): DWR Levee Log, 2005. USACE Sacramento O&M Manual 112, March 1957, (RM 34.47)].						
FS Date: 8/27/2013

WS view: steel pipe and pump on levee slope. Dense vegetation on waterside.

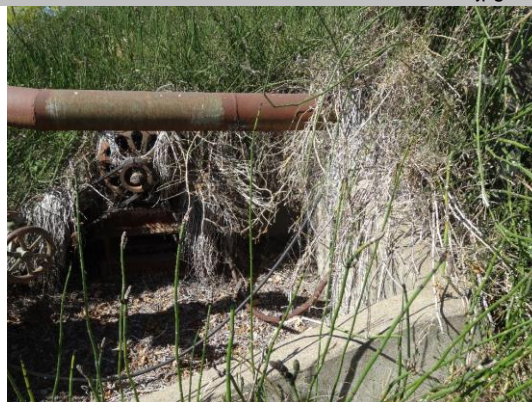
Photo 2 of 3 : UCIP_FA_2018_20267_34238.jpg

WS view: steel pipe and pump on concrete pad. Seems abandoned.

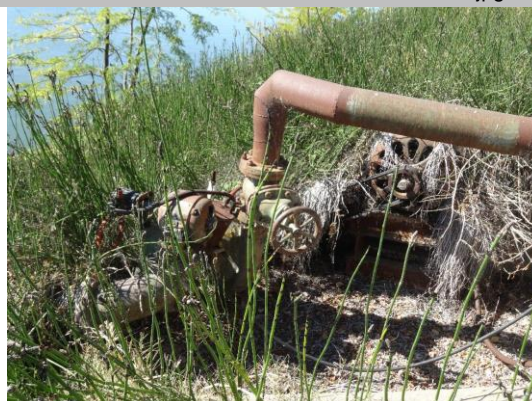
Photo 3 of 3 : UCIP_FA_2018_20267_34237.jpg

WS view: steel pipe, gate valve, and pump on levee slope. Seems abandoned.

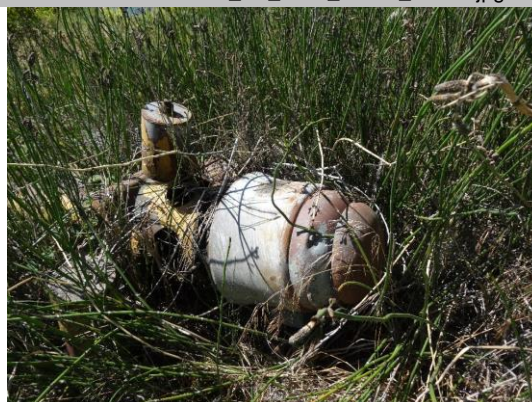
Photo 1 of 2 : UCIP_FA_2018_20284_34265.jpg

LM Start	0.48	Rating **	M	Issue No.	994
LM End	0.48	Issue Type +	En	Location *	
Category	Supplemental			GPS Latitude/Longitude	
				Start	End
Item	DWR UCIP Field Study			38.333754°	38.333754°
				-121.571018°	-121.571018°
DWR ID	22419				
Comment Code					
Inspector Comment					
FS_ID:20284 DS_ID:22419 EP_NO: N/A Repair Type: Non-Urgent Crossing Status: Found UCIP Comments: Needs proper abandonment. FIELD_STRUCT_DESC: 8-inch steel irrigation discharge pipe through the levee, invert elevation 5.7 feet below the crown. Power line on the landside (LS). (Retention of an irrigation pumping plant, a centrifugal pump, and an 8-inch steel pipe through the levee with a gate valve at the waterside [WS] end authorized under Permit No. 9446, 1974 - Hanna Olsen). [Additional Reference(s): DWR Levee Log, 2005. USACE Sacramento O&M Manual 112, March 1957, (RM 34.49)]. FS Date: 8/27/2013

WS view: abandoned pump on levee slope. Dense vegetation on waterside.

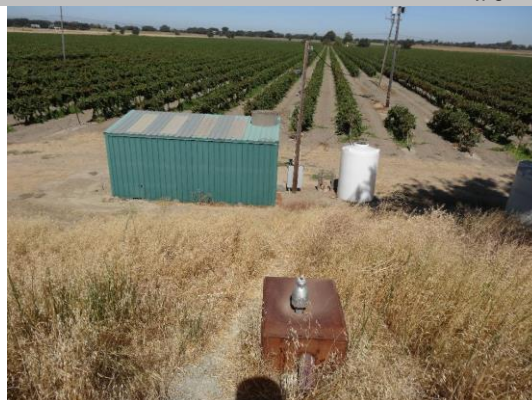
Photo 3 of 3 : UCIP_FA_2018_20303_34285.jpg

Comment Code						
Inspector Comment						
FS_ID:20303 DS_ID:22421 EP_NO: 16109 Repair Type: Non-Urgent Crossing Status: Found UCIP Comments: - 10" steel pipe on both sides of the levee. According to permit and inspectors note- 16" steel pipe through the levee.- concrete standpipe inside water filtration plant on landside toe.- air pressure tank on waterside steel deck. FIELD_STRUCT_DESC: 16-inch wrapped steel irrigation discharge pipe and a 2-inch electrical conduit through the levee, invert elevation 6.2 feet below the crown. Slant pump on a steel platform on the waterside (WS) slope. 4-inch abandoned pipe on the WS slope. Concrete standpipe and power pole at the landside (LS) toe. (Plans to replace an existing irrigation pipe with a 16-inch wrapped steel pipe through the levee, construct a 3-foot-square concrete anchorage block on the WS slope, and install a 2-inch utility pipe through the levee authorized under Permit No. 18258-Revised, 2007 - Wilson Farms, Inc). [Additional Reference(s): DWR Levee Log, 2005, 14-inch pipe referenced. USACE Sacramento O&M Manual 112, March 1957, (RM 34.71), 14-inch pipe referenced]. FS Date: 8/27/2013

LS view: 10-inch pipe and air vent on levee slope. Concrete standpipe inside water filtration plant.

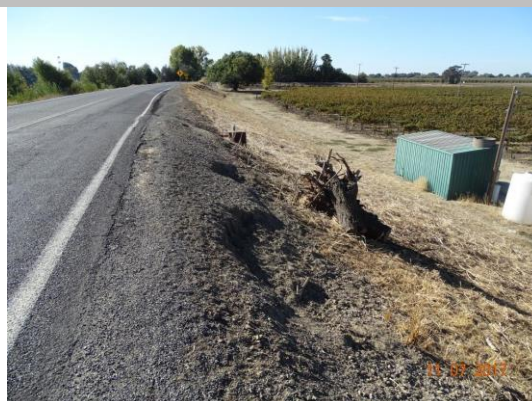
Photo 1 of 2 : FA_2018_RD0150_16_59_20180910_00040.jpg

LM Start	0.71	Rating **	M	Issue No.	59
LM End	0.71	Issue Type +	Ma	Location *	LS
Category	Earthen Levee			GPS Latitude/Longitude	
				Start	End
Item	Encroachments			38.336291 °	38.336291 °
				-121.568260 °	-121.568260 °
DWR ID	DWR_RD0150_02_s_2016_59				
Comment Code					
TR : Tree or limb					
Inspector Comment					
Damaged tree roots and trunks appear to damage landside slope of the levee and need to be removed.

View of the tree trunk on the landside of the levee. Fall 2017

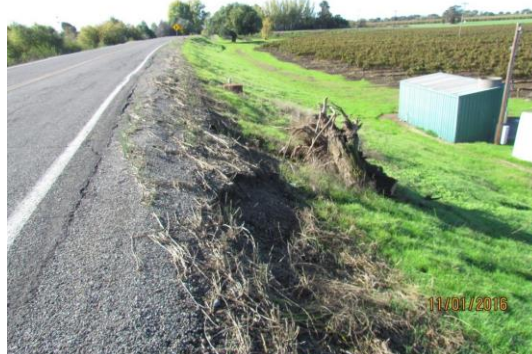
Photo 2 of 2 : FA_2018_RD0150_16_59_20180910_00041.jpg

View of the tree limbs and roots on the landside of the levee looking downstream. Fall 2016

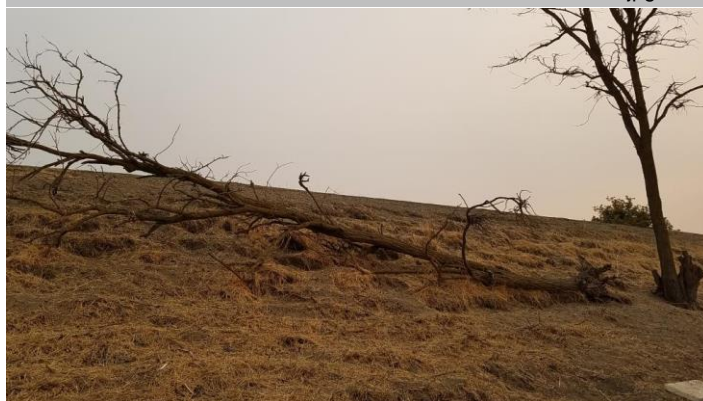
Photo 1 of 1 : FA_2018_RD0150_16_73_20181115_00134.jpg

LM Start	0.79	Rating **	M	Issue No.	73
LM End	0.79	Issue Type +	Ma	Location *	LS
Category	Earthen Levee			GPS Latitude/Longitude	
				Start	End
Item	Encroachments			38.337307°	38.337307°
				-121.567698°	-121.567698°
DWR ID	DWR_RD0150_02_f_2017_73				
Comment Code					
TR : Tree or limb					
Inspector Comment					
Landowner needs to remove dead tree from easement.

View of fallen tree on landside levee slope. Fall 2018

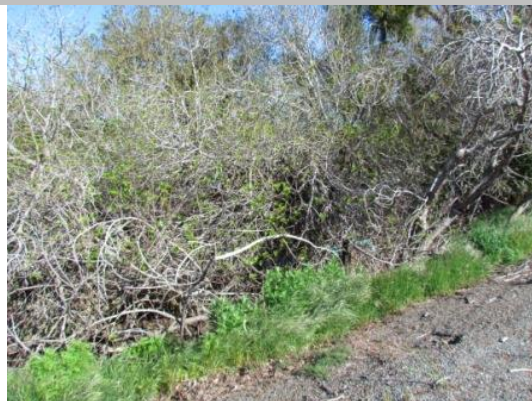
Photo 1 of 1 : FA_2018_RD0150_16_12_20180910_00007.jpg

LM Start	0.97	Rating **	U	Issue No.	12
LM End	0.97	Issue Type +	En	Location *	LS
Category	Earthen Levee			GPS Latitude/Longitude	
				Start	End
Item	Encroachments			38.339035 °	38.339035 °
				-121.565145 °	-121.565145 °
DWR ID	DWR_RD0150_02_s_2012_12				
Comment Code					
TR : Tree or limb					
Inspector Comment

Overgrown trees were obstructing the landside slope of the levee looking upstream.

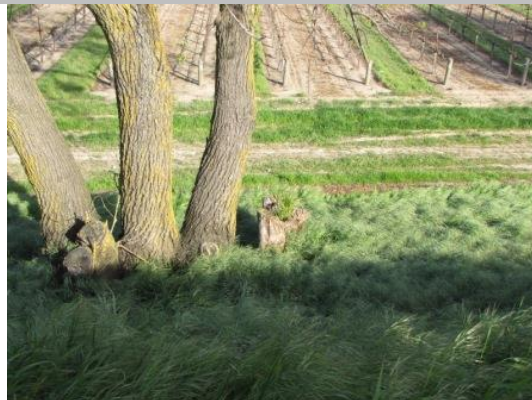
Photo 1 of 1 : FA_2018_RD0150_16_8_20180910_00005.jpg

LM Start	1.14	Rating **	N	Issue No.	8
LM End	1.14	Issue Type +	Ma	Location *	LS
Category	Earthen Levee			GPS Latitude/Longitude	
				Start	End
Item	Trim / Thin Trees			38.340864 °	38.340864 °
				-121.562915 °	-121.562915 °
DWR ID	DWR_RD0150_02_s _ 2012_8				
Comment Code					
T5 : Tree stumps.					
Inspector Comment

View of a tree stump on the landward slope.

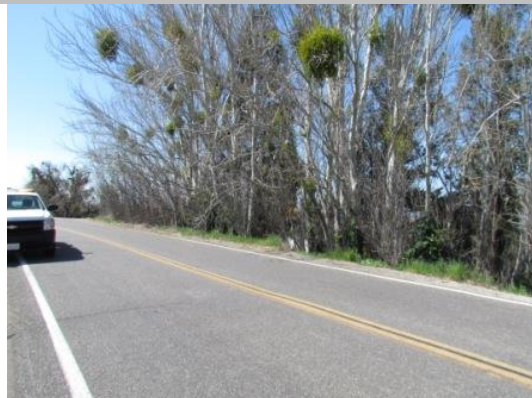
Photo 1 of 2 : FA_2018_RD0150_16_91_20180910_00057.jpg

LM Start	1.32	Rating **	U	Issue No.	91
LM End	1.35	Issue Type +	En	Location *	LS
Category	Earthen Levee			GPS Latitude/Longitude	
				Start	End
Item	Vegetation			38.343010 °	38.343276 °
				-121.561096 °	-121.560739 °
DWR ID	DWR_RD0150_02_s_2012_91				
Comment Code					
V6 : Landscaping					
Inspector Comment					
LMA needs to collect prunings from maintenance on shoulder.

Landscaping was obstructing the view of the landside slope of the levee looking downstream. This picture was taken during spring 2013 inspection.

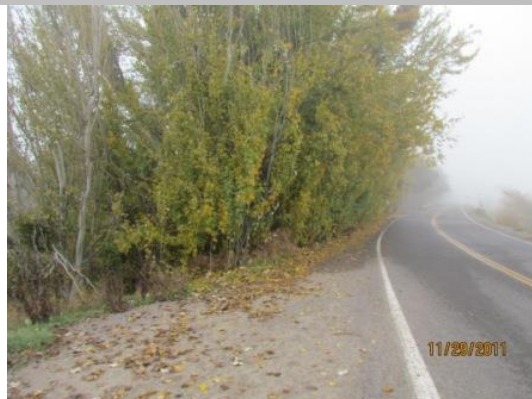
Photo 2 of 2 : FA_2018_RD0150_16_91_20180910_00058.jpg

Landscaping was found landside of the levee looking upstream. Fall 2011

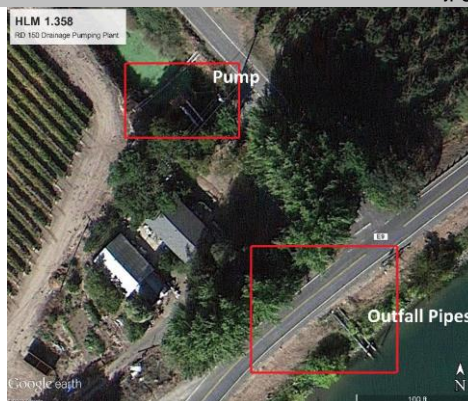
Photo 1 of 3 : UCIP_FA_2018_20727_34889.jpg

Comment Code						
Inspector Comment						
FS_ID:20727						
DS_ID:22393						
EP_NO: 18221						
Repair Type: Non-Urgent						
Crossing Status: Found						
UCIP Comments: Pump house and drainage ditch about 250 feet from the levee on landside.Pumps on piling structure with shed in drainage ditch.Siphon breaker cover missing. Needs to fix it.						
FIELD_STRUCT_DESC: [Reclamation District No. 150 (RD0150) Drainage Plant] 1 of 2: 30-inch steel drainage discharge pipe through the levee, 7 feet below the crown. Flap gate on the waterside (WS) end. Siphon breaker on the WS slope. Pump on a piling structure with a shed in the drainage ditch. (Plans to replace existing 36-inch and 24-inch discharge pipes with 30-inch and 24-inch steel discharge pipes through the levee authorized under Permit No. 18221, 2007 - RD0150). [Additional Reference(s): DWR Levee Log, 2005, 36-inch pipe referenced, 9 feet below the crown. USACE Sacramento O&M Manual 112, March 1957, (RM 35.36), 36-inch pipe referenced, invert elevation 9 feet below the crown].

Bird's eye view: outfall pipes (bottom) and pump structure in drainage ditch (top)

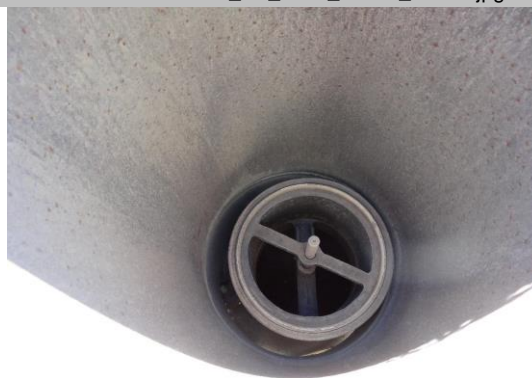
Photo 2 of 3 : UCIP_FA_2018_20727_34888.jpg

WS view: siphon breaker in pipe riser on levee shoulder.

Comment Code						
Inspector Comment						
FS_ID:20727 DS_ID:22393 EP_NO: 18221 Repair Type: Non-Urgent Crossing Status: Found UCIP Comments: Pump house and drainage ditch about 250 feet from the levee on landside.Pumps on piling structure with shed in drainage ditch.Siphon breaker cover missing. Needs to fix it. FIELD_STRUCT_DESC: [Reclamation District No. 150 (RD0150) Drainage Plant] 1 of 2: 30-inch steel drainage discharge pipe through the levee, 7 feet below the crown. Flap gate on the waterside (WS) end. Siphon breaker on the WS slope. Pump on a piling structure with a shed in the drainage ditch. (Plans to replace existing 36-inch and 24-inch discharge pipes with 30-inch and 24-inch steel discharge pipes through the levee authorized under Permit No. 18221, 2007 - RD0150). [Additional Reference(s): DWR Levee Log, 2005, 36-inch pipe referenced, 9 feet below the crown. USACE Sacramento O&M Manual 112, March 1957, (RM 35.36), 36-inch pipe referenced, invert elevation 9 feet below the crown]. FS Date: 8/27/2013

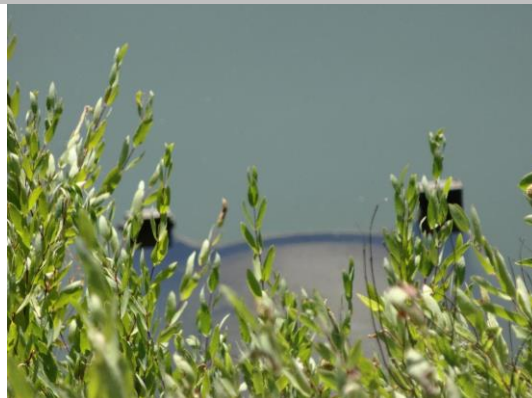
Photo 3 of 3 : UCIP_FA_2018_20727_34887.jpg

WS view: submerged flap gate in the stream.

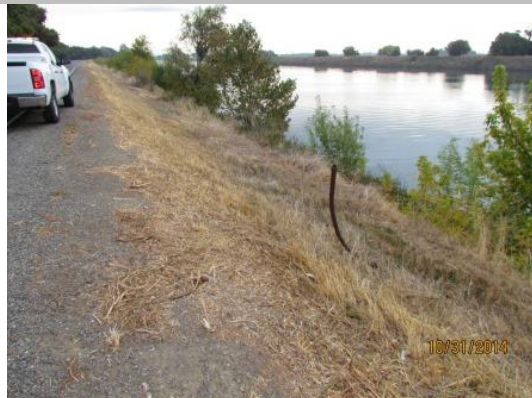
Photo 1 of 1 : FA_2018_RD0150_16_48_20180910_00026.jpg

LM Start	1.73	Rating **	M	Issue No.	48
LM End	1.73	Issue Type +	En	Location *	WS
Category	Earthen Levee			GPS Latitude/Longitude	
				Start	End
Item	Encroachments			38.345583 °	38.345583 °
				-121.554507 °	-121.554507 °
DWR ID	DWR_RD0150_02_f_2014_48				
Comment Code					
PO : Pole					
Inspector Comment					
A pole was found on the waterside slope of the levee. Most probably is connected to a pump.

A pole/pipe was found on the waterside slope of the levee looking upstream. Fall 2014

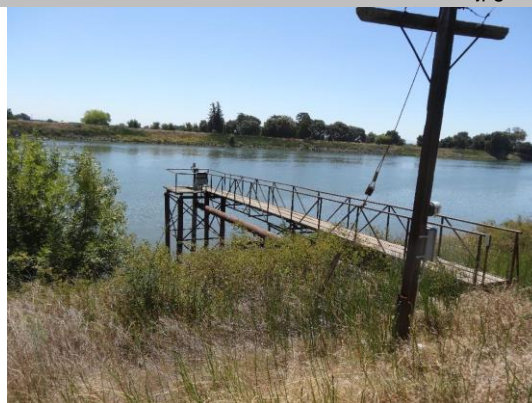
Photo 1 of 3 : UCIP_FA_2018_20348_34371.jpg

Comment Code					
Inspector Comment					
FS_ID:20348					
DS_ID:22395					
EP_NO: N/A					
Repair Type: Non-Urgent					
Crossing Status: Found					
UCIP Comments: - Operating during inspection.- Overhead powerline crossing- CMP riser with siphon breaker needs cleaning.					
FIELD_STRUCT_DESC: 12-inch steel irrigation discharge pipe through the levee, invert elevation 4 feet below the crown. Pump on a piling structure in the river. Power poles on both slopes. Ramp on the landside (LS) slope. Siphon breaker on the LS shoulder. [Additional Reference(s): DWR Levee Log, 2005. USACE Sacramento O&M Manual 112, March 1957, (RM 35.94)].					
FS Date: 8/27/2013

WS view: service pole, pipe & pump on piling structure in the stream.

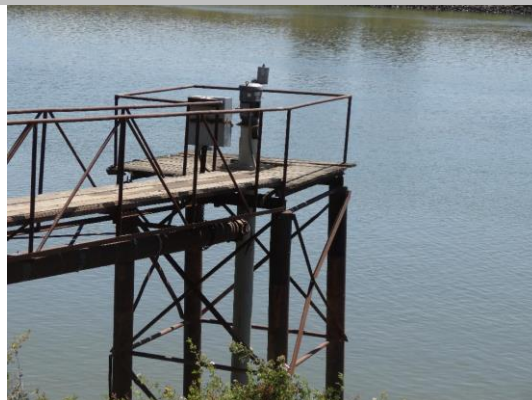
Photo 2 of 3 : UCIP_FA_2018_20348_34370.jpg

WS view: pipe & pump on piling structure in the stream.

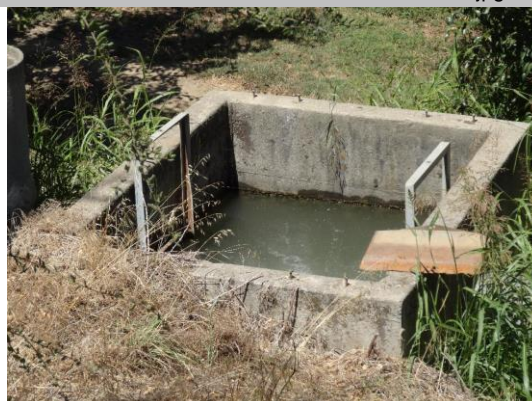
Photo 3 of 3 : UCIP_FA_2018_20348_34369.jpg

Comment Code						
Inspector Comment						
FS_ID:20348						
DS_ID:22395						
EP_NO: N/A						
Repair Type: Non-Urgent						
Crossing Status: Found						
UCIP Comments: - Operating during inspection.- Overhead powerline crossing- CMP riser with siphon breaker needs cleaning.						
FIELD_STRUCT_DESC: 12-inch steel irrigation discharge pipe through the levee, invert elevation 4 feet below the crown. Pump on a piling structure in the river. Power poles on both slopes. Ramp on the landside (LS) slope. Siphon breaker on the LS shoulder. [Additional Reference(s): DWR Levee Log, 2005. USACE Sacramento O&M Manual 112, March 1957, (RM 35.94)].						
FS Date: 8/27/2013

LS view: concrete distribution box on levee toe.

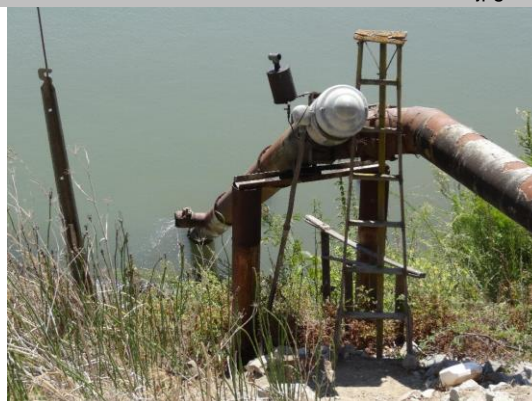
Photo 1 of 3 : UCIP_FA_2018_20731_34902.jpg

LM Start	2.14	Rating **	M	Issue No.	998	
LM End	2.14	Issue Type +	En	Location *		
Category	Supplemental			GPS Latitude/Longitude		
				Start	End	
Item	DWR UCIP Field Study			38.347032 °	38.347032 °	
				-121.547159 °	-121.547159 °	
DWR ID	22396					
Comment Code						
Inspector Comment						
FS_ID:20731						
DS_ID:22396						
EP_NO: N/A						
Repair Type: Non-Urgent						
Crossing Status: Found						
UCIP Comments: - Operating during inspection. Leaky join at the concrete box.- Power overhead crossing. Power pole at waterside shoulder, and landside toe.						
FIELD_STRUCT_DESC: 12-inch steel irrigation discharge pipe through the levee, invert elevation 5 feet below the crown. Slant pump on the waterside (WS) slope. Power pole on the WS shoulder. [Additional Reference(s): DWR Levee Log, 2005. USACE Sacramento O&M Manual 112, March 1957, (RM 36.17)].						
FS Date: 8/27/2013

WS view: slant pump on steel frame support and exposed pipe on levee slope.

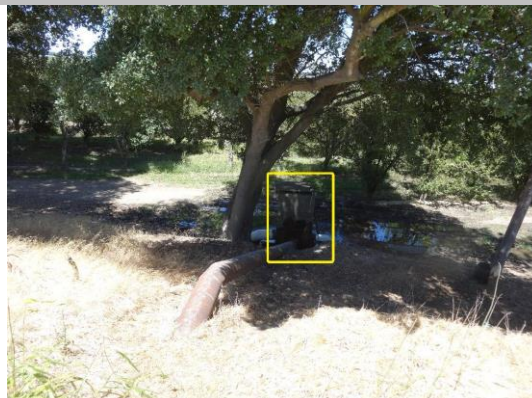
Photo 2 of 3 : UCIP_FA_2018_20731_34901.jpg

LS view: concrete distribution box on levee toe and exposed steel pipe on levee slope.

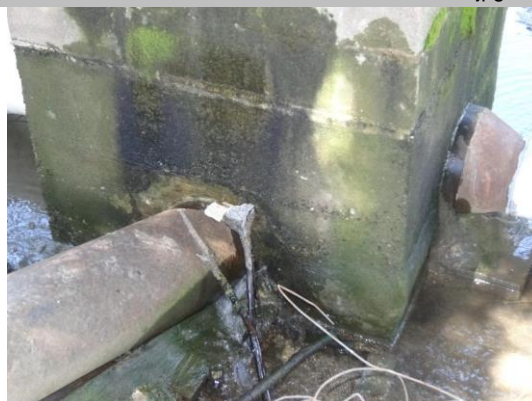
Photo 3 of 3 : UCIP_FA_2018_20731_34903.jpg

LM Start	2.14	Rating **	M	Issue No.	998 (cont)	
LM End	2.14	Issue Type +	En	Location *		
Category	Supplemental			GPS Latitude/Longitude		
				Start		End
Item	DWR UCIP Field Study			38.347032 °		38.347032 °
				-121.547159 °		-121.547159 °
DWR ID	22396					
Comment Code						
Inspector Comment						
FS_ID:20731 DS_ID:22396 EP_NO: N/A Repair Type: Non-Urgent Crossing Status: Found UCIP Comments: - Operating during inspection. Leaky join at the concrete box.- Power overhead crossing. Power pole at waterside shoulder, and landside toe. FIELD_STRUCT_DESC: 12-inch steel irrigation discharge pipe through the levee, invert elevation 5 feet below the crown. Slant pump on the waterside (WS) slope. Power pole on the WS shoulder. [Additional Reference(s): DWR Levee Log, 2005. USACE Sacramento O&M Manual 112, March 1957, (RM 36.17)]. FS Date: 8/27/2013

LS view: leaky concrete distribution box on levee toe.

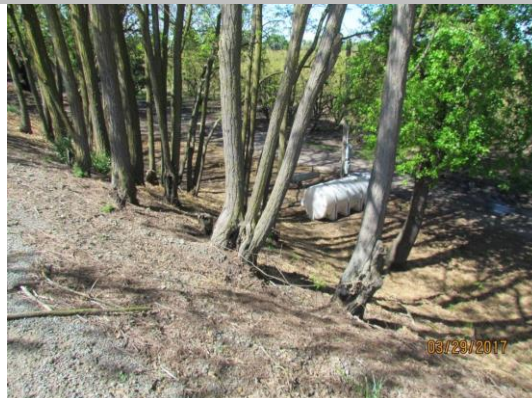
Photo 1 of 1 : FA_2018_RD0150_16_70_20180910_00047.jpg

LM Start	2.72	Rating **	M	Issue No.	70
LM End	2.72	Issue Type +	En	Location *	LS
Category	Earthen Levee			GPS Latitude/Longitude	
				Start	End
Item	Encroachments			38.349777 °	38.349777 °
				-121.537247 °	-121.537247 °
DWR ID	DWR_RD0150_02_s_2017_70				
Comment Code					
TA : Tank					
Inspector Comment

A tank was found on the landside toe of the levee. Spring 2017

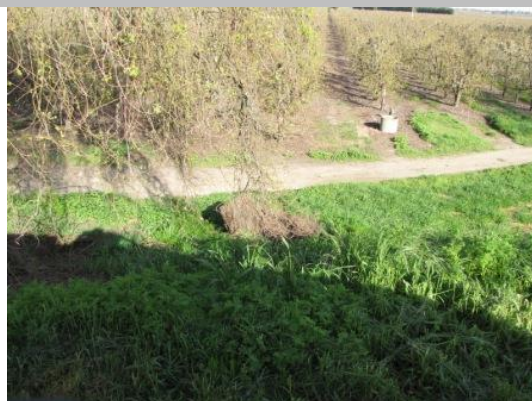
Photo 1 of 1 : FA_2018_RD0150_16_14_20180910_00009.jpg

LM Start	2.75	Rating **	N	Issue No.	14
LM End	2.75	Issue Type +	Ma	Location *	LS
Category	Earthen Levee			GPS Latitude/Longitude	
				Start	End
Item	Trim / Thin Trees			38.350041 °	38.350041 °
				-121.536853 °	-121.536853 °
DWR ID	DWR_RD0150_02_s_2012_14				
Comment Code					
T5 : Tree stumps.					
Inspector Comment

View of a tree stump on the landward slope.

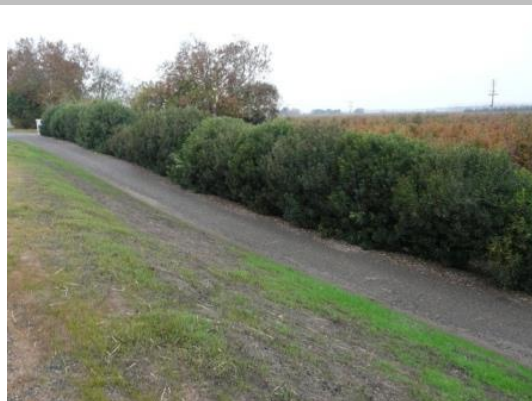
Photo 1 of 1 : FA_2018_RD0150_16_85_20180910_00054.jpg

LM Start	2.97	Rating **	U	Issue No.	85
LM End	3.01	Issue Type +	En	Location *	LS
Category	Earthen Levee			GPS Latitude/Longitude	
				Start	End
Item	Vegetation			38.352372 °	38.352802 °
				-121.534127 °	-121.533638 °
DWR ID	DWR_RD0150_02_s_2012_85				
Comment Code					
V6 : Landscaping					
Inspector Comment

Landscaping providing a screen for a residence on the landside of levee.

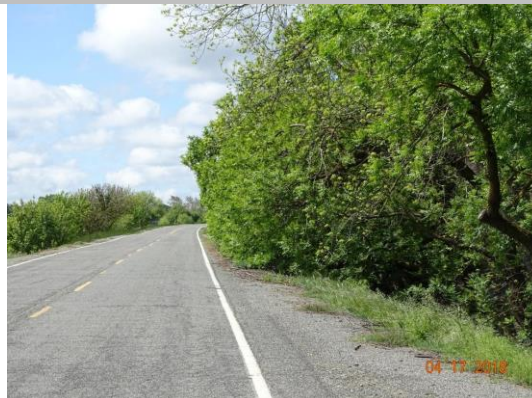
Photo 1 of 1 : FA_2018_RD0150_16_95_20180910_00059.jpg

LM Start	3.08	Rating **	U	Issue No.	95
LM End	3.10	Issue Type +	En	Location *	LS
Category	Earthen Levee			GPS Latitude/Longitude	
				Start	End
Item	Vegetation			38.353541 °	38.353822 °
				-121.532844 °	-121.532574 °
DWR ID	DWR_RD0150_02_s _ 2018_95				
Comment Code					
V6 : Landscaping					
Inspector Comment					
Trim trees on landside slope.

Vegetation landside looking southwest. Spring 2018

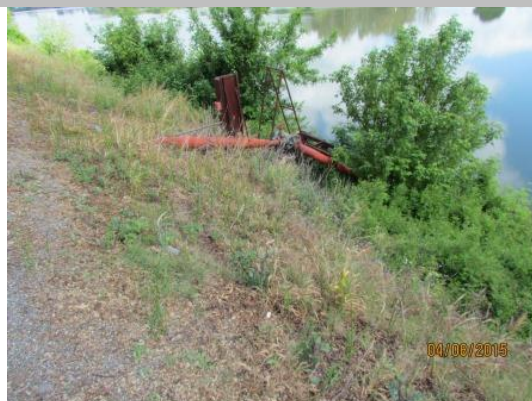
Photo 1 of 5 : FA_2018_RD0150_16_961_20180910_00065.jpg

LM Start	3.24	Rating **	M	Issue No.	961
LM End	3.24	Issue Type +	Ma	Location *	WS
Category	Earthen Levee			GPS Latitude/Longitude	
				Start	End
Item	Erosion / Bank Caving			38.355321 °	38.355321 °
				-121.530902 °	-121.530902 °
DWR ID	DWR_RD0150_02_s _ 2012_961				
Comment Code					
E2 : Schedule repair of erosion site prior to the next inspection.					
Inspector Comment					
Depressions into the waterward slope can be seen along the waterward slope at this site. Also note the damaged pump support, pump, and pipe just upstream of the site; they may contribute to the erosion in a high water event and should be removed.

View of the erosion on the waterside of the levee during spring 2015 inspection.

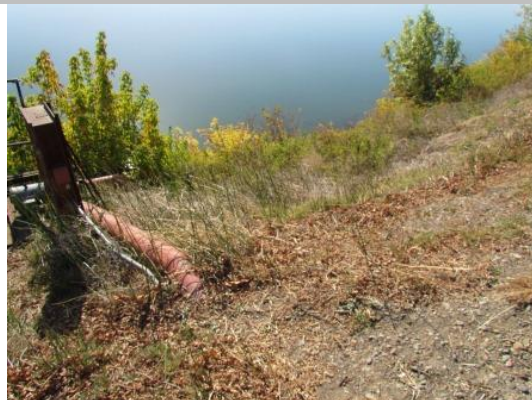
Photo 2 of 5 : FA_2018_RD0150_16_961_20180910_00066.jpg

View of the erosion on the waterside slope of the levee near the pipe looking downstream. This picture was taken during the fall 2013 inspection.

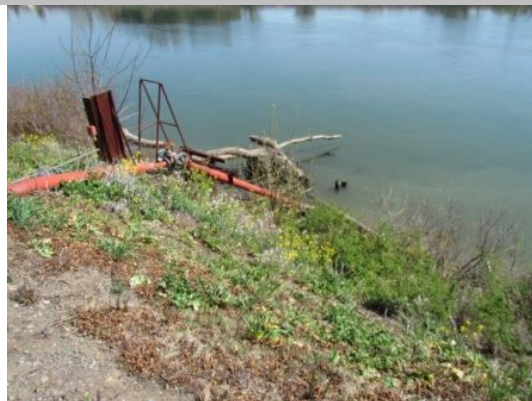
Photo 3 of 5 : FA_2018_RD0150_16_961_20180910_00067.jpg

View of the erosion on the waterside slope of the levee looking upstream during spring 2013 inspection.

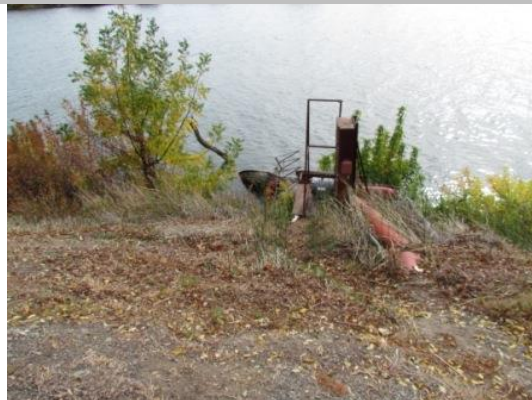
Photo 4 of 5 : FA_2018_RD0150_16_961_20180910_00068.jpg

LM Start	3.24	Rating **	M	Issue No.	961 (cont)
LM End	3.24	Issue Type +	Ma	Location *	WS
Category	Earthen Levee			GPS Latitude/Longitude	
				Start	End
Item	Erosion / Bank Caving			38.355321 °	38.355321 °
				-121.530902 °	-121.530902 °
DWR ID	DWR_RD0150_02_s_2012_961				
Comment Code					
E2 : Schedule repair of erosion site prior to the next inspection.					
Inspector Comment					
Depressions into the waterward slope can be seen along the waterward slope at this site. Also note the damaged pump support, pump, and pipe just upstream of the site; they may contribute to the erosion in a high water event and should be removed.

View of erosion and damaged pipe and abandoned boat on the waterside of the levee looking upstream. This picture was taken during fall 2012 inspection.

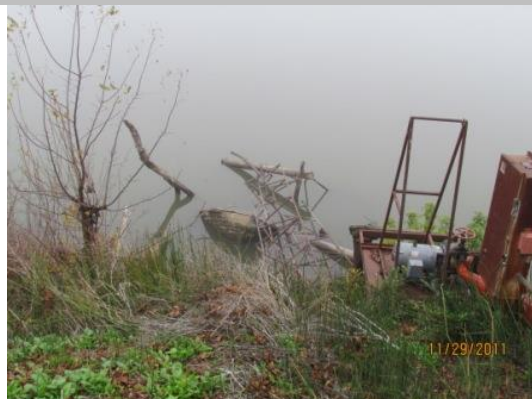
Photo 5 of 5 : FA_2018_RD0150_16_961_20180910_00069.jpg

View of the erosion site, and broken pump support along with a boat on the waterside of the levee. The picture was taken from the crown looking towards the toe of the levee during fall 2011 inspection.

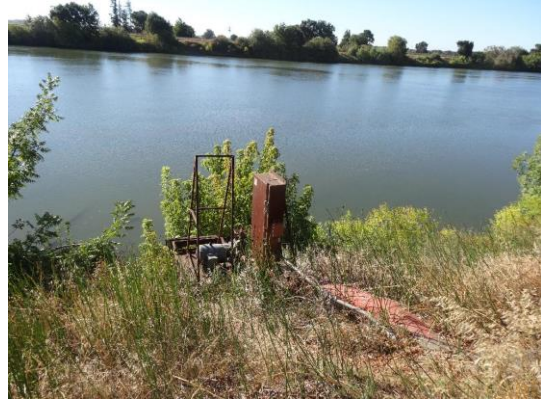
Photo 1 of 3 : UCIP_FA_2018_20736_34917.jpg

Comment Code						
Inspector Comment						
FS_ID:20736 DS_ID:22402 EP_NO: N/A Repair Type: Non-Urgent Crossing Status: Found UCIP Comments: - 10" steel pipe sleeved through 12" steel pipe.- main pipe bifurcates into two pipes on LS slope and connected to standpipe and concrete box.- 2" electric conduit on WS and power pole on LS.- needs filling into gap between 10" and 12" steel pipes on LS. FIELD_STRUCT_DESC: 12-inch steel irrigation discharge pipe through the levee, invert elevation 4 feet below the crown. Pump on a piling structure in the river. Concrete standpipe and concrete distribution box at the landside (LS) toe. (A. Green). [Additional Reference(s): DWR Levee Log, 2005. USACE Sacramento O&M Manual 112, March 1957, (RM 37.30)]. FS Date: 8/30/2013

WS view: pipe, conduit and pump on levee slope.

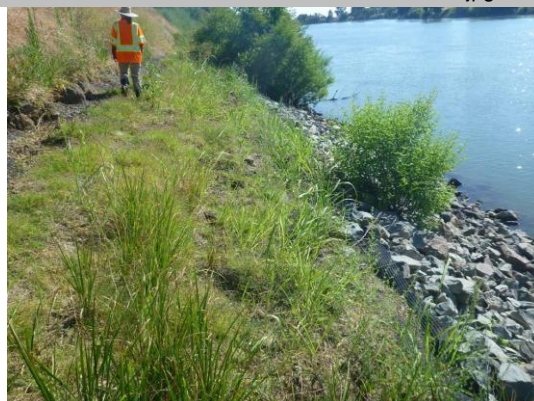
Photo 3 of 3 : LEVAL_FA_2018_287_2149.jpg

Comment Code					
Inspector Comment					
Levee Evaluation Comments					
Description:The flood damage consists of a waterside erosion approximately 229 feet long on the west (right) bank of the Sacramento River. See attached pages for photos.					
Site ID No:287					
Site Designation:LMA-113					
Repair Type: Erosion					
Rating:Serious					
Field Date:7/17/2017					
Notes: Crown is a paved road. Erosion scarps upto 10 ft deep and within 5 ft of crown. Worse conditions on the DS end. Exposed filter fabric. Serious because of depth of erosion into levee, weak soil, and proximity to crown which is a high traffic public road.

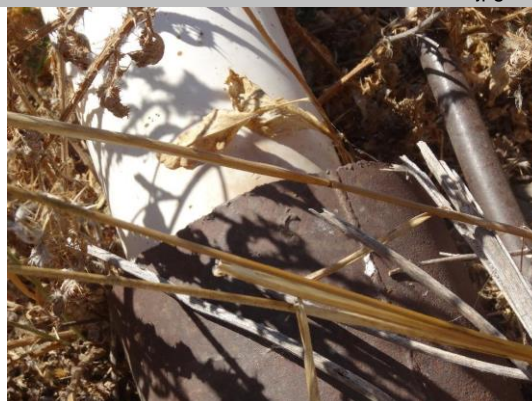
Photo 2 of 3 : UCIP_FA_2018_19846_33726.jpg

Comment Code						
Inspector Comment						
FS_ID:19846 DS_ID:22403 EP_NO: N/A Repair Type: Non-Urgent Crossing Status: Found UCIP Comments: - 8" pvc pipe sleeved into 12" steel pipe.- needs filling/grouting in gap between 8" pvc pipe and 12" steel pipe on WS.- 1.5" electric conduit on WS- 10" steel pipe extended to 8" pvc pipe on landside levee toe. FIELD_STRUCT_DESC: 12-inch steel irrigation discharge pipe through the levee, invert elevation 3 feet below the crown. Pump and gate valve on the waterside (WS) slope. (R. and J. Pylman). [Additional Reference(s): DWR Levee Log, 2005. USACE Sacramento O&M Manual 112, March 1957, (RM 37.56)]. FS Date: 8/30/2013

WS view: steel conduit (right); 8" pvc pipe sleeved into 12" steel pipe.

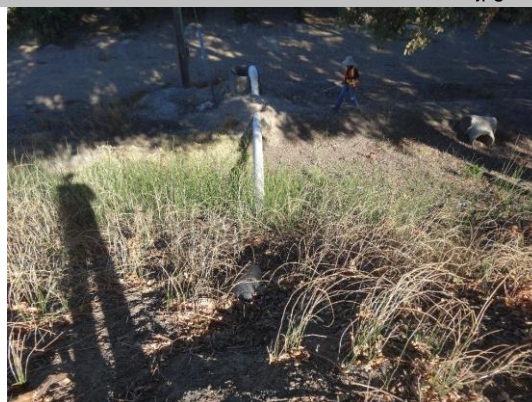
Photo 3 of 3 : UCIP_FA_2018_19846_33725.jpg

LS view: exposed pipe on levee slope and standpipe on the toe.

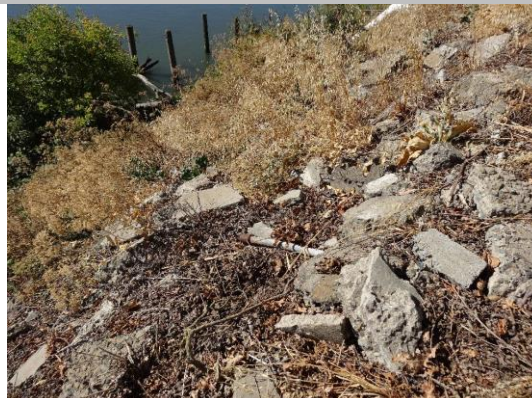
Photo 1 of 3 : UCIP_FA_2018_19848_33734.jpg

LM Start	3.51	Rating **	M	Issue No.	1001
LM End	3.51	Issue Type +	En	Location *	
Category	Supplemental			GPS Latitude/Longitude	
				Start	End
Item	DWR UCIP Field Study			38.358131°	38.358131°
				-121.527540°	-121.527540°
DWR ID	22404				
Comment Code					
Inspector Comment					
FS_ID:19848 DS_ID:22404 EP_NO: N/A Repair Type: Non-Urgent Crossing Status: Found UCIP Comments: - needs proper abandonment. FIELD_STRUCT_DESC: *ABANDONED* 4-inch steel pipe of an unknown purpose on the landside (LS) slope. 1-inch steel conduit on the waterside (WS) slope was found. FS Date: 8/30/2013

WS view: abandoned 1-inch conduit on levee slope.

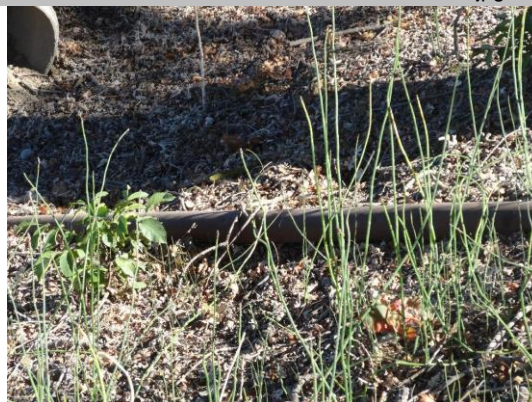
Photo 2 of 3 : UCIP_FA_2018_19848_33733.jpg

LS view: exposed 4-inch steel pipe on levee slope.

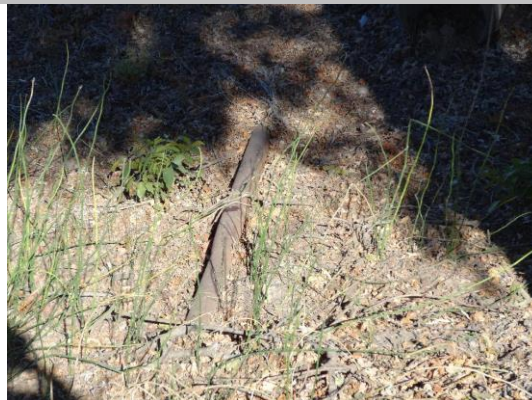
Photo 3 of 3 : UCIP_FA_2018_19848_33732.jpg

LM Start	3.51	Rating **	M	Issue No.	1001 (cont)
LM End	3.51	Issue Type +	En	Location *	
Category	Supplemental			GPS Latitude/Longitude	
				Start	End
Item	DWR UCIP Field Study			38.358131°	38.358131°
				-121.527540°	-121.527540°
DWR ID	22404				
Comment Code					
Inspector Comment					
FS_ID:19848 DS_ID:22404 EP_NO: N/A Repair Type: Non-Urgent Crossing Status: Found UCIP Comments: - needs proper abandonment. FIELD_STRUCT_DESC: *ABANDONED* 4-inch steel pipe of an unknown purpose on the landside (LS) slope. 1-inch steel conduit on the waterside (WS) slope was found. FS Date: 8/30/2013

LS view: abandoned 4-inch steel pipe on levee slope.

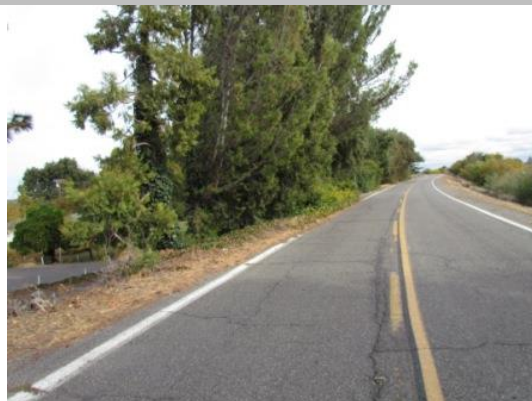
Photo 1 of 1 : FA_2018_RD0150_16_82_20180910_00053.jpg

LM Start	3.54	Rating **	U	Issue No.	82
LM End	3.67	Issue Type +	En	Location *	LS
Category	Earthen Levee			GPS Latitude/Longitude	
				Start	End
Item	Vegetation			38.358530°	38.359749°
				-121.527162°	-121.525245°
DWR ID	DWR_RD0150_02_s_2012_82				
Comment Code					
V6 : Landscaping					
Inspector Comment

Landscaping was blocking the visibility on the landside of the levee looking upstream.

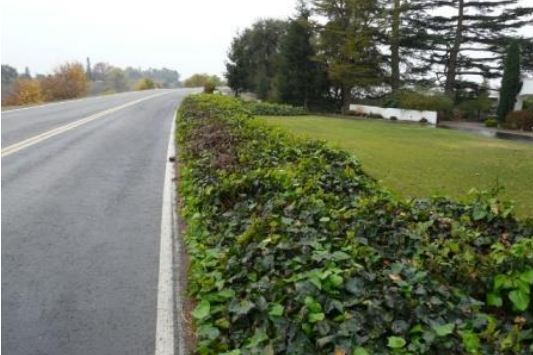
Photo 1 of 1 : FA_2018_RD0150_16_80_20180910_00052.jpg

Landscaping in front of a residence on landside of levee. The levee in this location is greater than 100' wide.

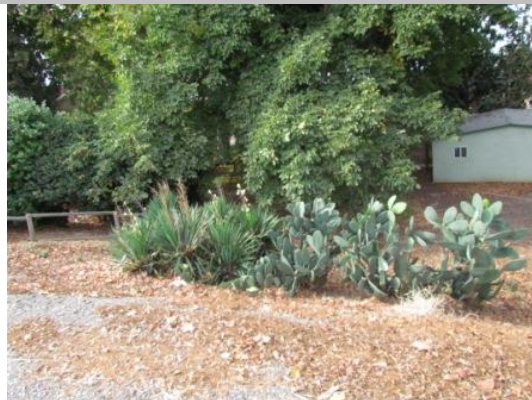
Photo 1 of 1 : FA_2018_RD0150_16_953_20180910_00064.jpg

LM Start	4.11	Rating **	M	Issue No.	953
LM End	4.11	Issue Type +	En	Location *	LS
Category	Earthen Levee			GPS Latitude/Longitude	
				Start	End
Item	Vegetation			38.365267 °	38.365267 °
				-121.522379 °	-121.522379 °
DWR ID	DWR_RD0150_02_s_2012_953				
Comment Code					
V6 : Landscaping					
Inspector Comment

View of cacti on the landside of the levee looking from the crown.

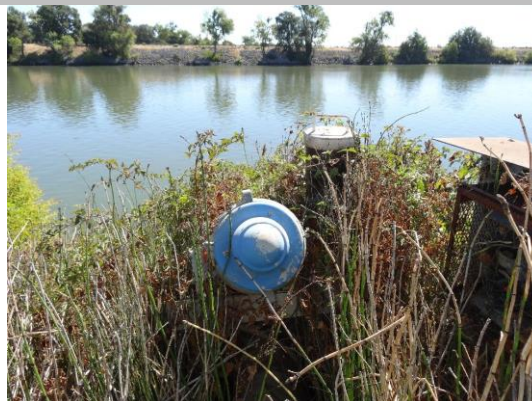
Photo 1 of 3 : UCIP_FA_2018_42702_33782.jpg

Comment Code						
Inspector Comment						
FS_ID:42702 DS_ID:22407 EP_NO: 13505 Repair Type: Non-Urgent Crossing Status: Found UCIP Comments: Appears abandoned and if so should be done so properly.- no pipe and structure found on landside.- siphon breaker in 24" CMP riser on waterside.- control box and electric conduit on waterside slope. FIELD_STRUCT_DESC: 14-inch steel irrigation discharge pipe through the levee, invert elevation 5 feet below the crown. Slant pump on the waterside (WS) slope. Siphon breaker on the WS slope in a corrugated metal pipe (CMP) riser. Control box and electrical conduit on the WS slope. (Plans to replace an existing pipeline with a 14-inch steel pipeline through the levee authorized under Permit No. 13505, 1982 - Gary Pylman). [Additional Reference(s): DWR Levee Log, 2005, 10-inch pipe referenced. USACE Sacramento O&M Manual 112, March 1957, (RM 38.24), 10-inch pipe referenced]. FS Date: 8/30/2013

WS view: slanted pump on levee slope.

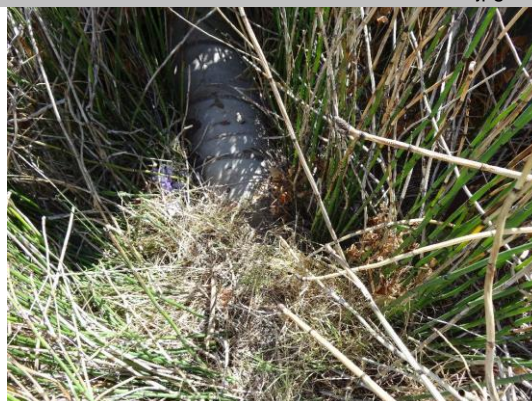
Photo 2 of 3 : UCIP_FA_2018_42702_33781.jpg

Comment Code					
Inspector Comment					
FS_ID:42702 DS_ID:22407 EP_NO: 13505 Repair Type: Non-Urgent Crossing Status: Found UCIP Comments: Appears abandoned and if so should be done so properly.- no pipe and structure found on landside.- siphon breaker in 24" CMP riser on waterside.- control box and electric conduit on waterside slope. FIELD_STRUCT_DESC: 14-inch steel irrigation discharge pipe through the levee, invert elevation 5 feet below the crown. Slant pump on the waterside (WS) slope. Siphon breaker on the WS slope in a corrugated metal pipe (CMP) riser. Control box and electrical conduit on the WS slope. (Plans to replace an existing pipeline with a 14-inch steel pipeline through the levee authorized under Permit No. 13505, 1982 - Gary Pylman). [Additional Reference(s): DWR Levee Log, 2005, 10-inch pipe referenced. USACE Sacramento O&M Manual 112, March 1957, (RM 38.24), 10-inch pipe referenced]. FS Date: 8/30/2013

WS view: exposed 14-inch steel pipe on levee slope.

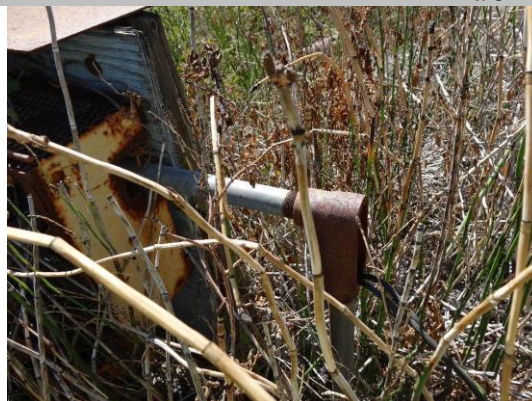
Photo 3 of 3 : UCIP_FA_2018_42702_33780.jpg

WS view: electric control box and electric conduit on levee slope.

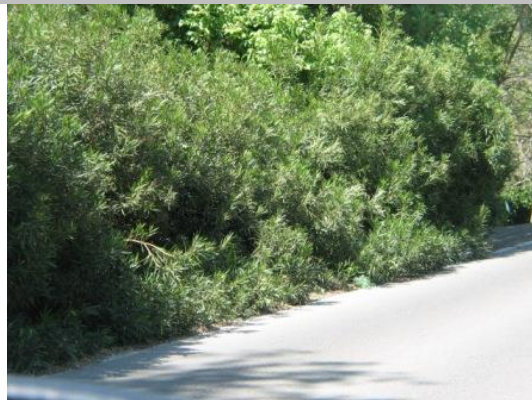
Photo 1 of 1 : FA_2018_RD0150_16_24_20180910_00011.jpg

LM Start	4.26	Rating **	U	Issue No.	24
LM End	4.28	Issue Type +	En	Location *	LS
Category	Earthen Levee			GPS Latitude/Longitude	
				Start	End
Item	Vegetation			38.367442°	38.367740°
				-121.522427°	-121.522495°
DWR ID	DWR_RD0150_02_s_2012_24				
Comment Code					
V6 : Landscaping					
Inspector Comment

Landscaping (Oleander) on landward slope

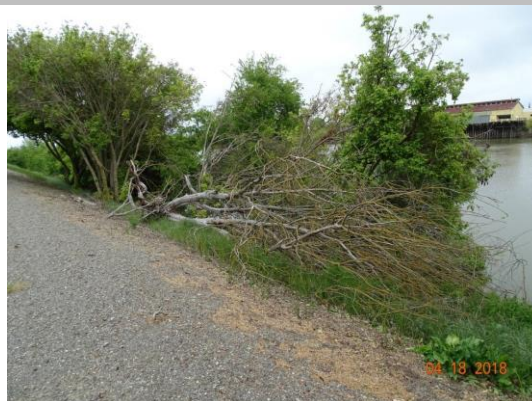
Photo 1 of 1 : FA_2018_RD0150_16_107_20180910_00062.jpg

LM Start	4.27	Rating **	M	Issue No.	107
LM End	4.27	Issue Type +	En	Location *	WS
Category	Earthen Levee			GPS Latitude/Longitude	
				Start	End
Item	Encroachments			38.367507 °	38.367507 °
				-121.522493 °	-121.522493 °
DWR ID	DWR_RD0150_02_s_2018_107				
Comment Code					
TR : Tree or limb					
Inspector Comment					
Remove downed tree on waterside slope.

View of fallen tree on waterside looking northeast. Spring 2018

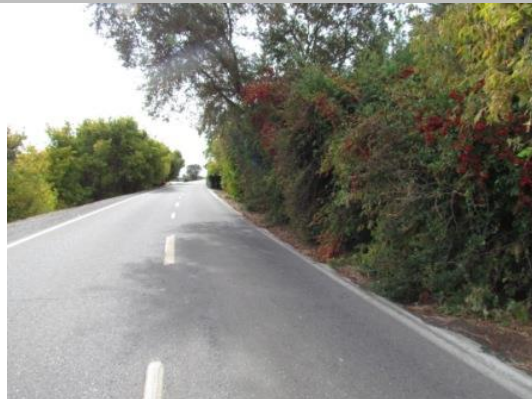
Photo 1 of 1 : FA_2018_RD0150_16_79_20180910_00051.jpg

LM Start	4.30	Rating **	U	Issue No.	79
LM End	4.34	Issue Type +	En	Location *	LS
Category	Earthen Levee			GPS Latitude/Longitude	
				Start	End
Item	Vegetation			38.368036 °	38.368540 °
				-121.522611 °	-121.522729 °
DWR ID	DWR_RD0150_02_s_2012_79				
Comment Code					
V6 : Landscaping					
Inspector Comment

Trees were obstructing the views on the landside slope of the levee looking downstream.

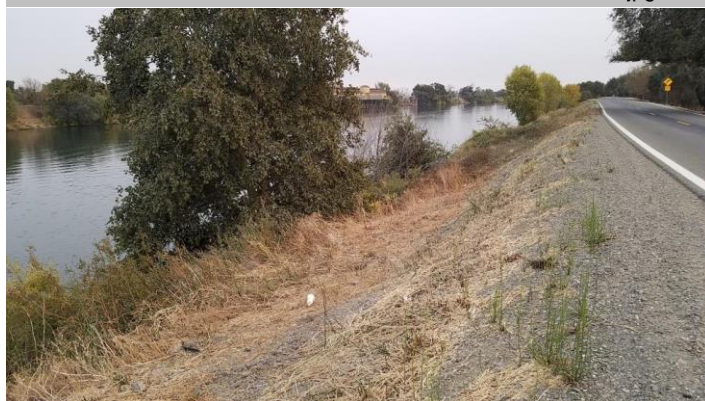
Photo 1 of 2 : FA_2018_RD0150_16_44_20181115_00139.jpg

2017 Field Notes: New erosion pocket. Vertical section along lower bank, and cracking. Upgraded to critical.

Fall 2018 DWR Inspection: Erosion along lower bank and cracking not visible from levee crown due to vegetation.

LM Start	4.50	Rating **	U	Issue No.	44 (cont)
LM End	4.57	Issue Type +	Ma	Location *	WS

View of waterside slope. Fall 2018

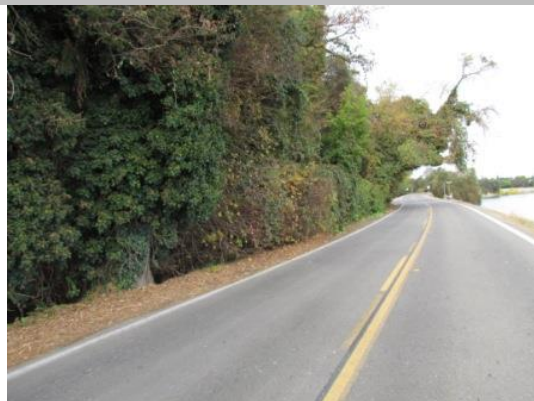
Photo 1 of 1 : FA_2018_RD0150_16_76_20180910_00049.jpg

Trees were obstructing the view of the landside slope of the levee looking upstream.
